# SIEMENS

## MODULARIS Uro

### Update Instructions

Title: Reinforcement of tabletop

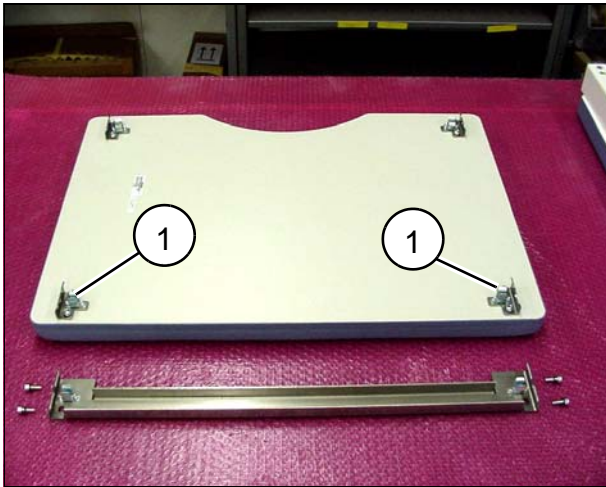
Fig. 1

A heavier load placed on the examination area can cause the affected part of the tabletop to break, which can lead to personal injury, under certain circumstances to serious personal injury.

- Move the tabletop upwards.
- Remove both mounting clips (1/Fig. 1 and 1/Fig. 2) from the back side of the tabletop.
- Position the rail according to (Fig. 3) and loosely screw it on with the supplied screws (1/Fig. 4).
- Position the top on the table so that the clips lock in place and the strut is in alignment.
- Tighten the screws from underneath (1/Fig. 4).
